Residuals Management Somersworth Drinking Water Treatment Facility

**A HISTORICAL
OVERVIEW OF
SURFACE WATER
TREATMENT
RESIDUALS
HANDLING**

Ian Rohrbacher, Treatment Operator IV

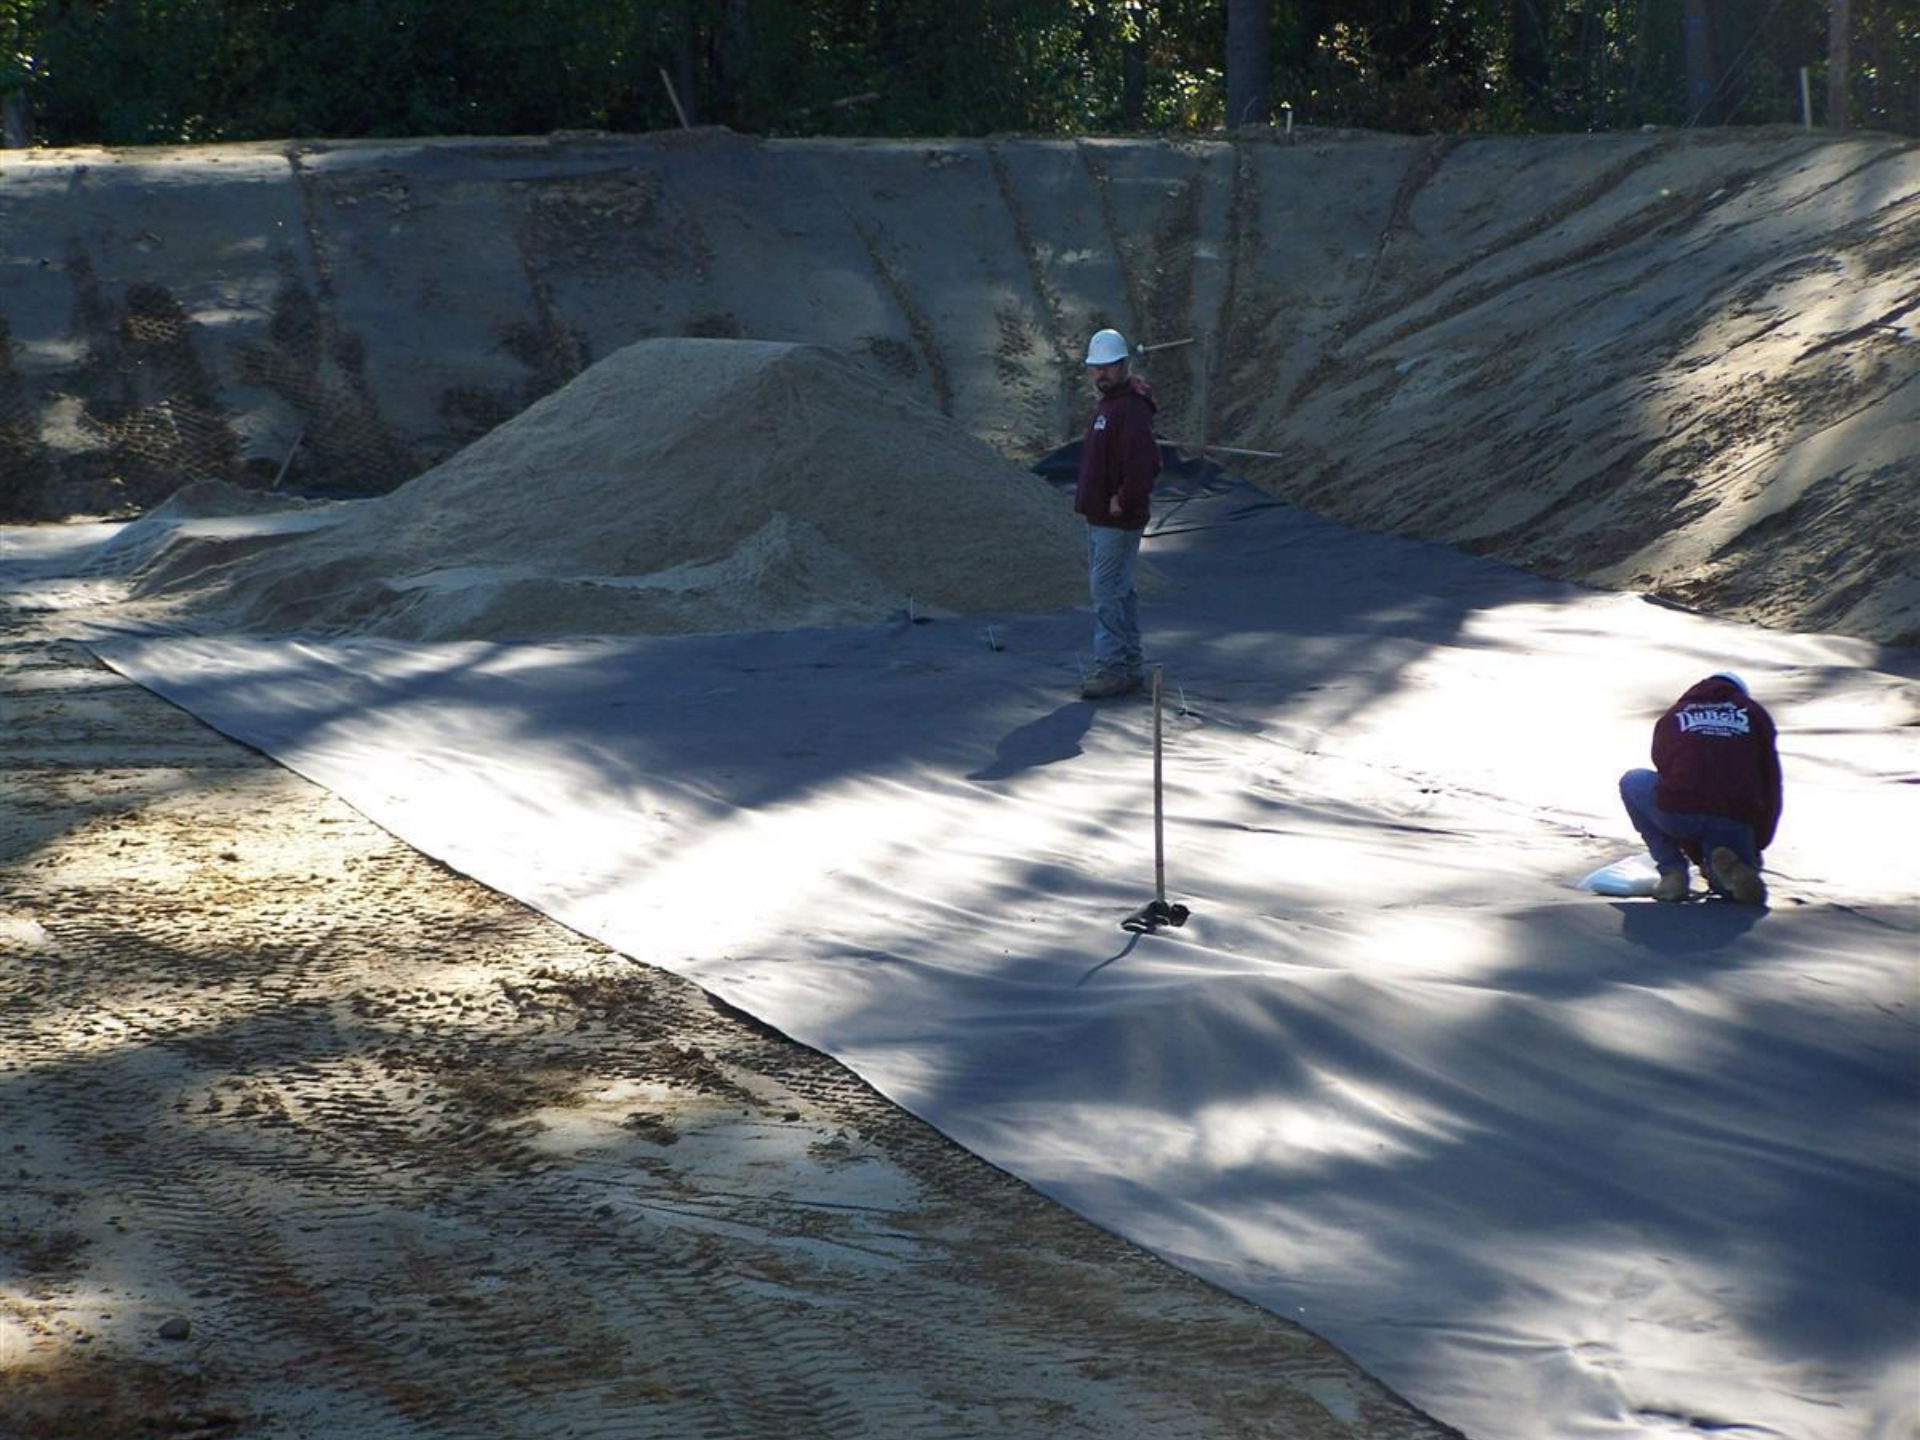
- Lagoon & recycle system integral part of our entire treatment process
- Dilutes raw water
- Collect hydrocyclone waste from the clarifier
- Backwash waste from filters
- Daily: 79,000 gals waste from clarifier, 54,000 gallons per 2 backwashes
- #1 ~22,000 ft², #2&3 ~15,000 ft² each. 4 feet deep.
- Each lagoon contains a groundwater super-under drain

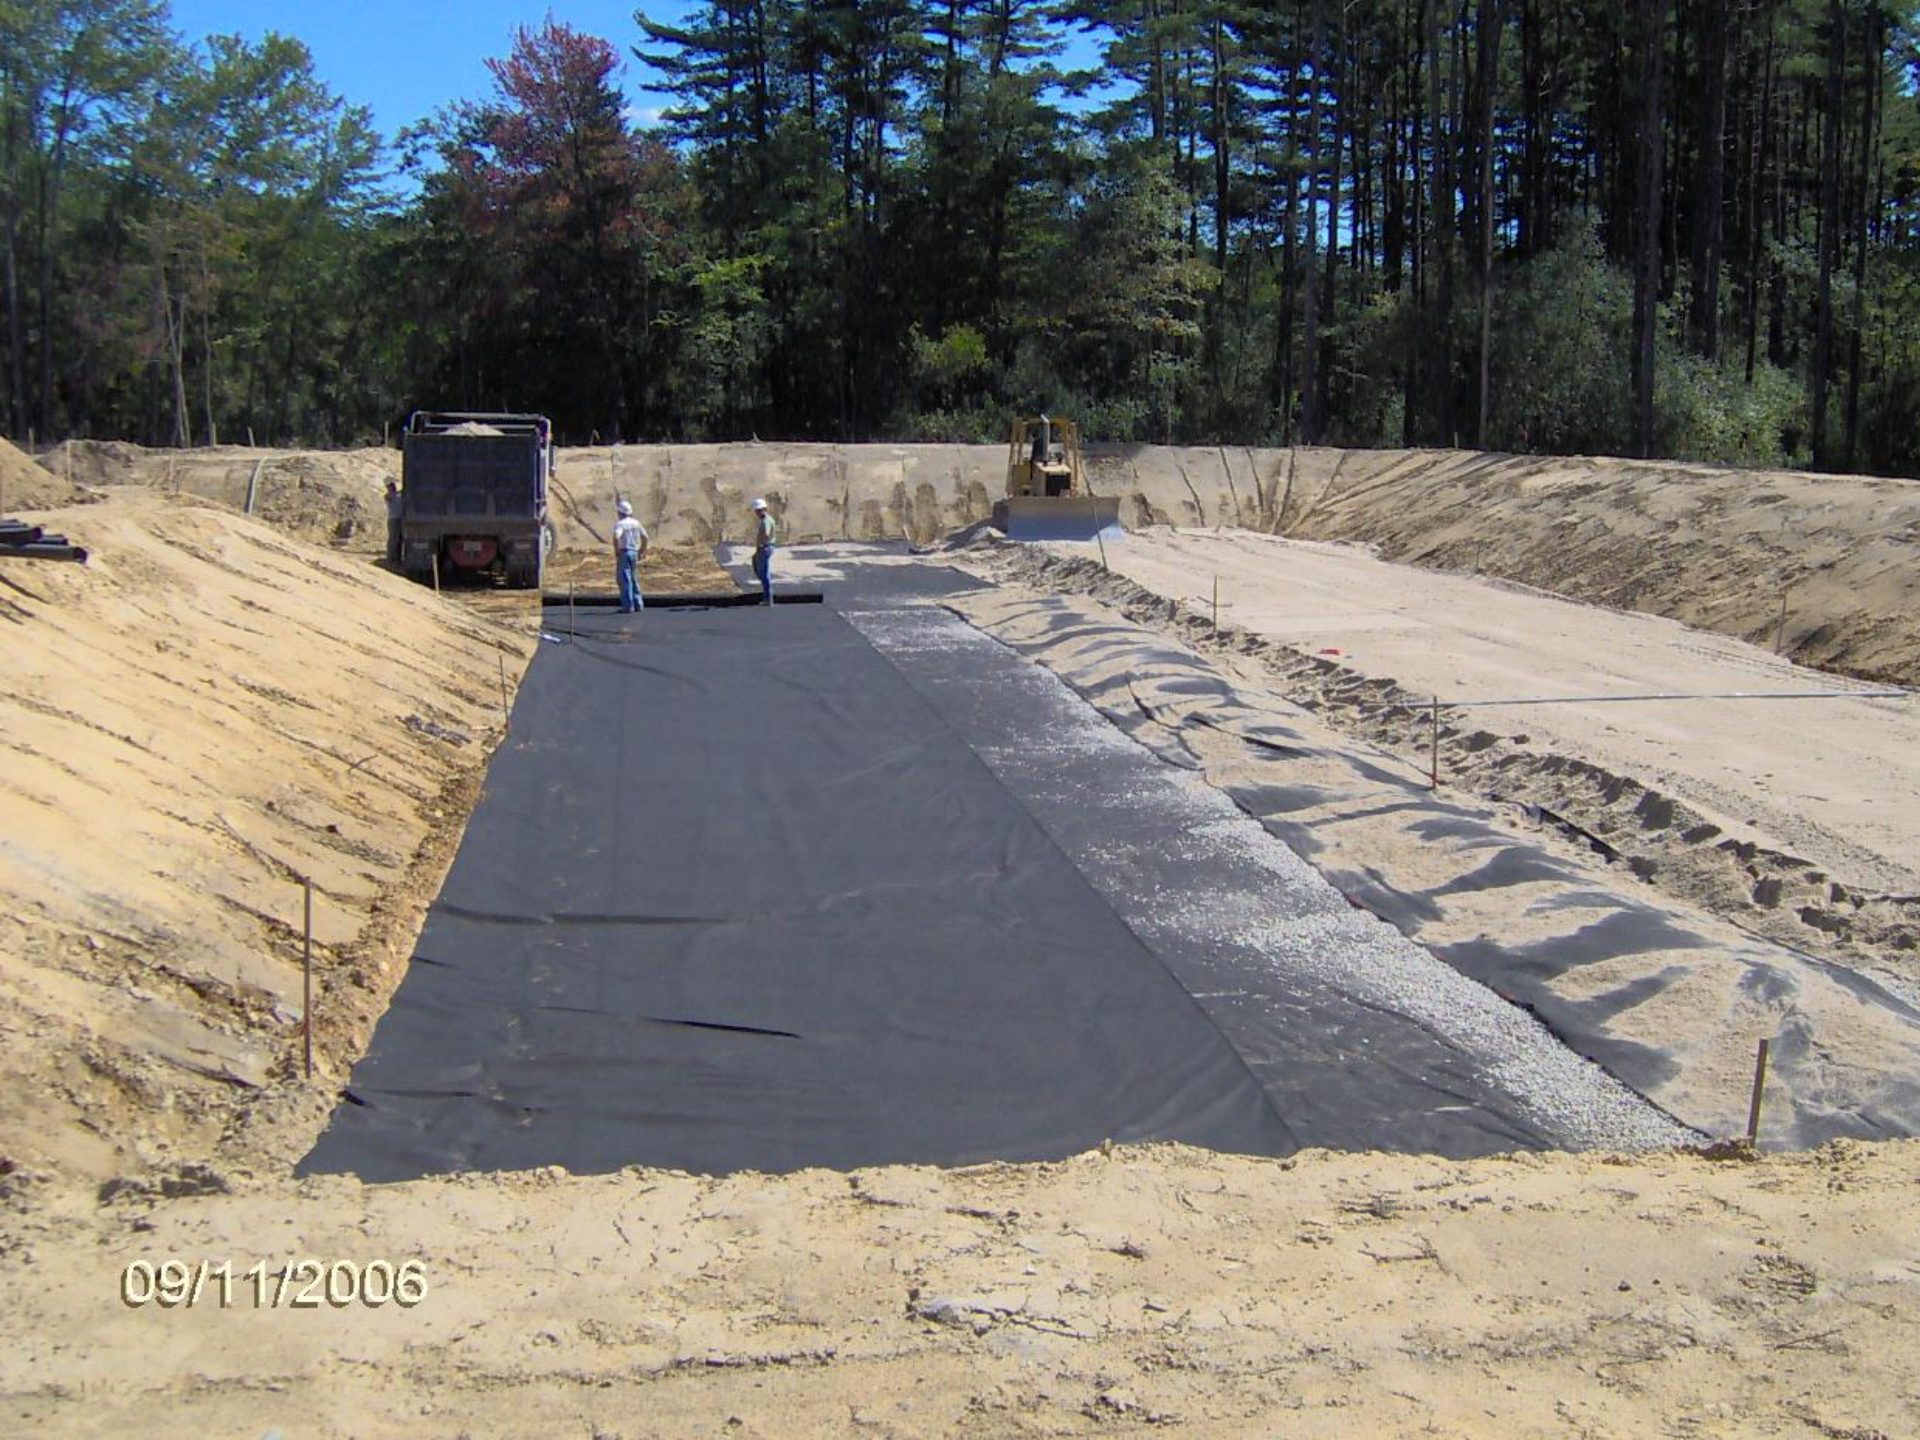
09/11/2006

- Stone and sand dewatering layers

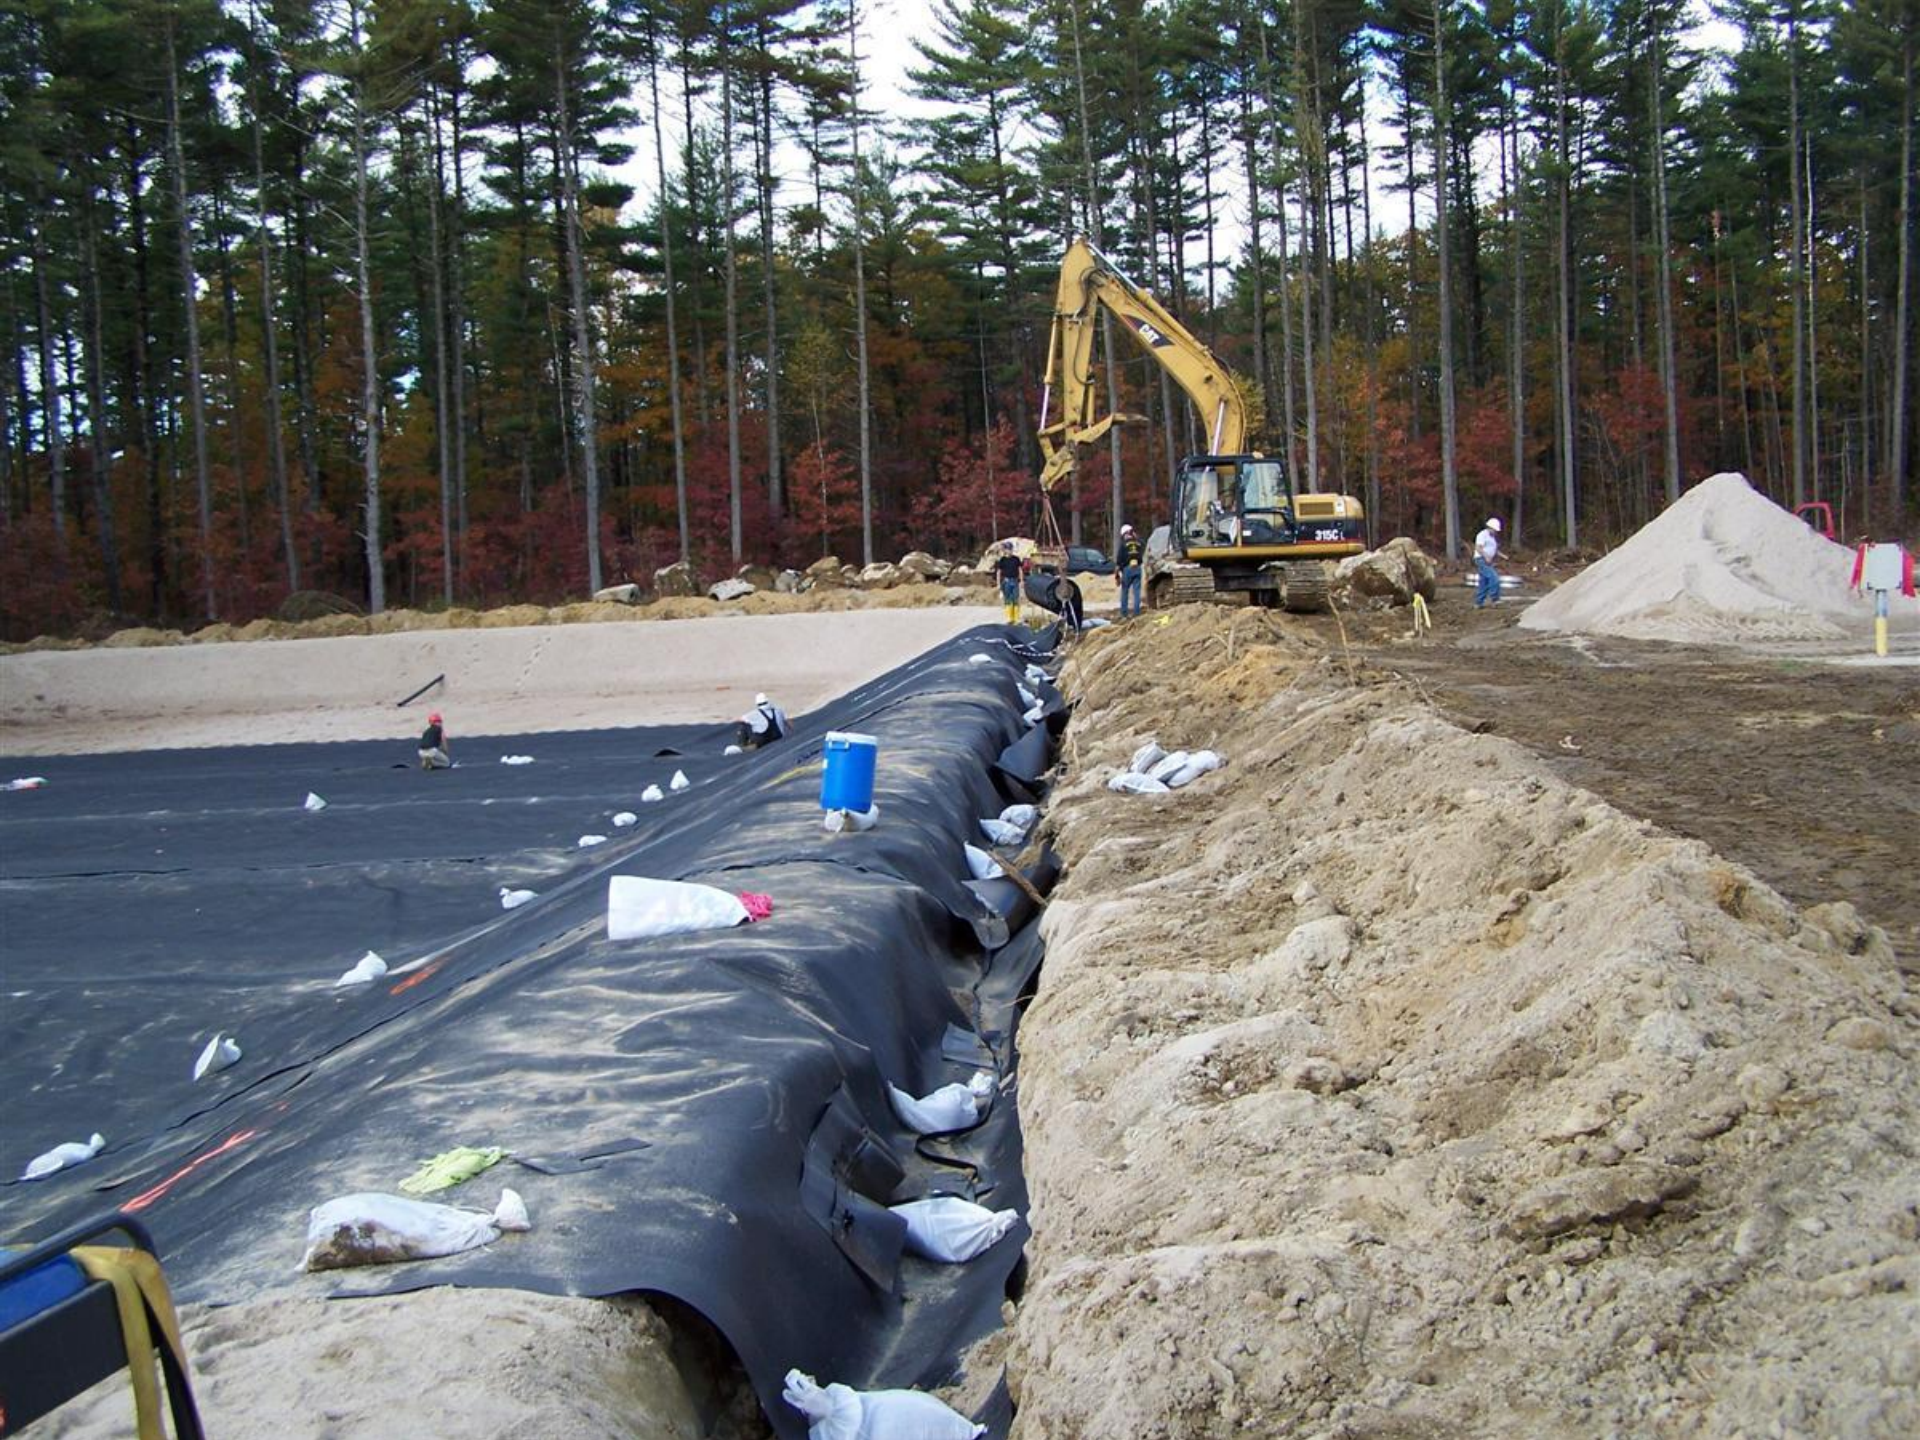
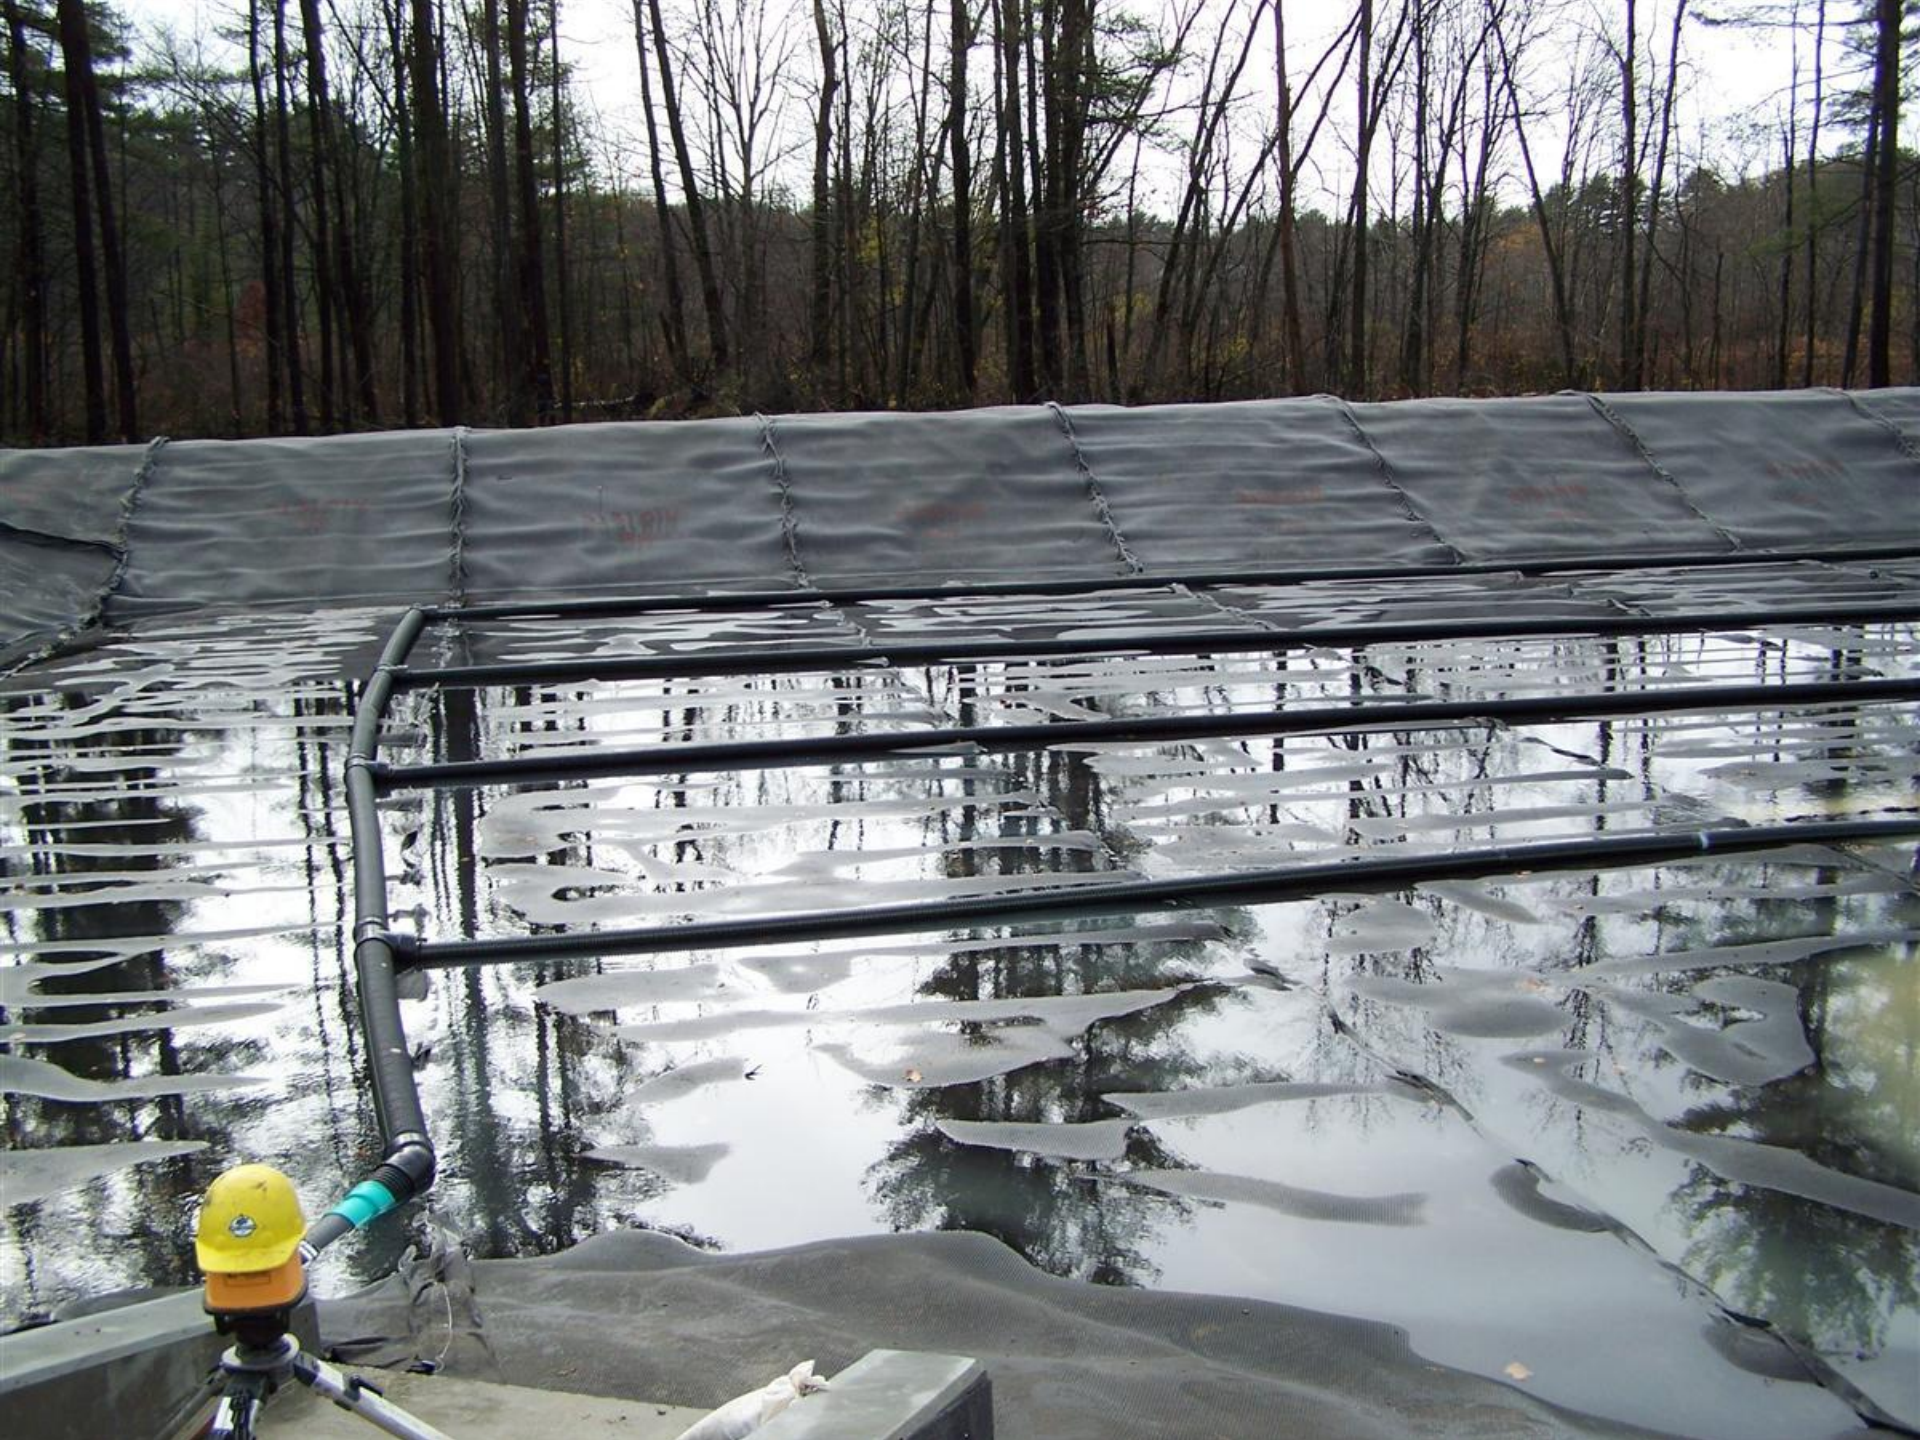
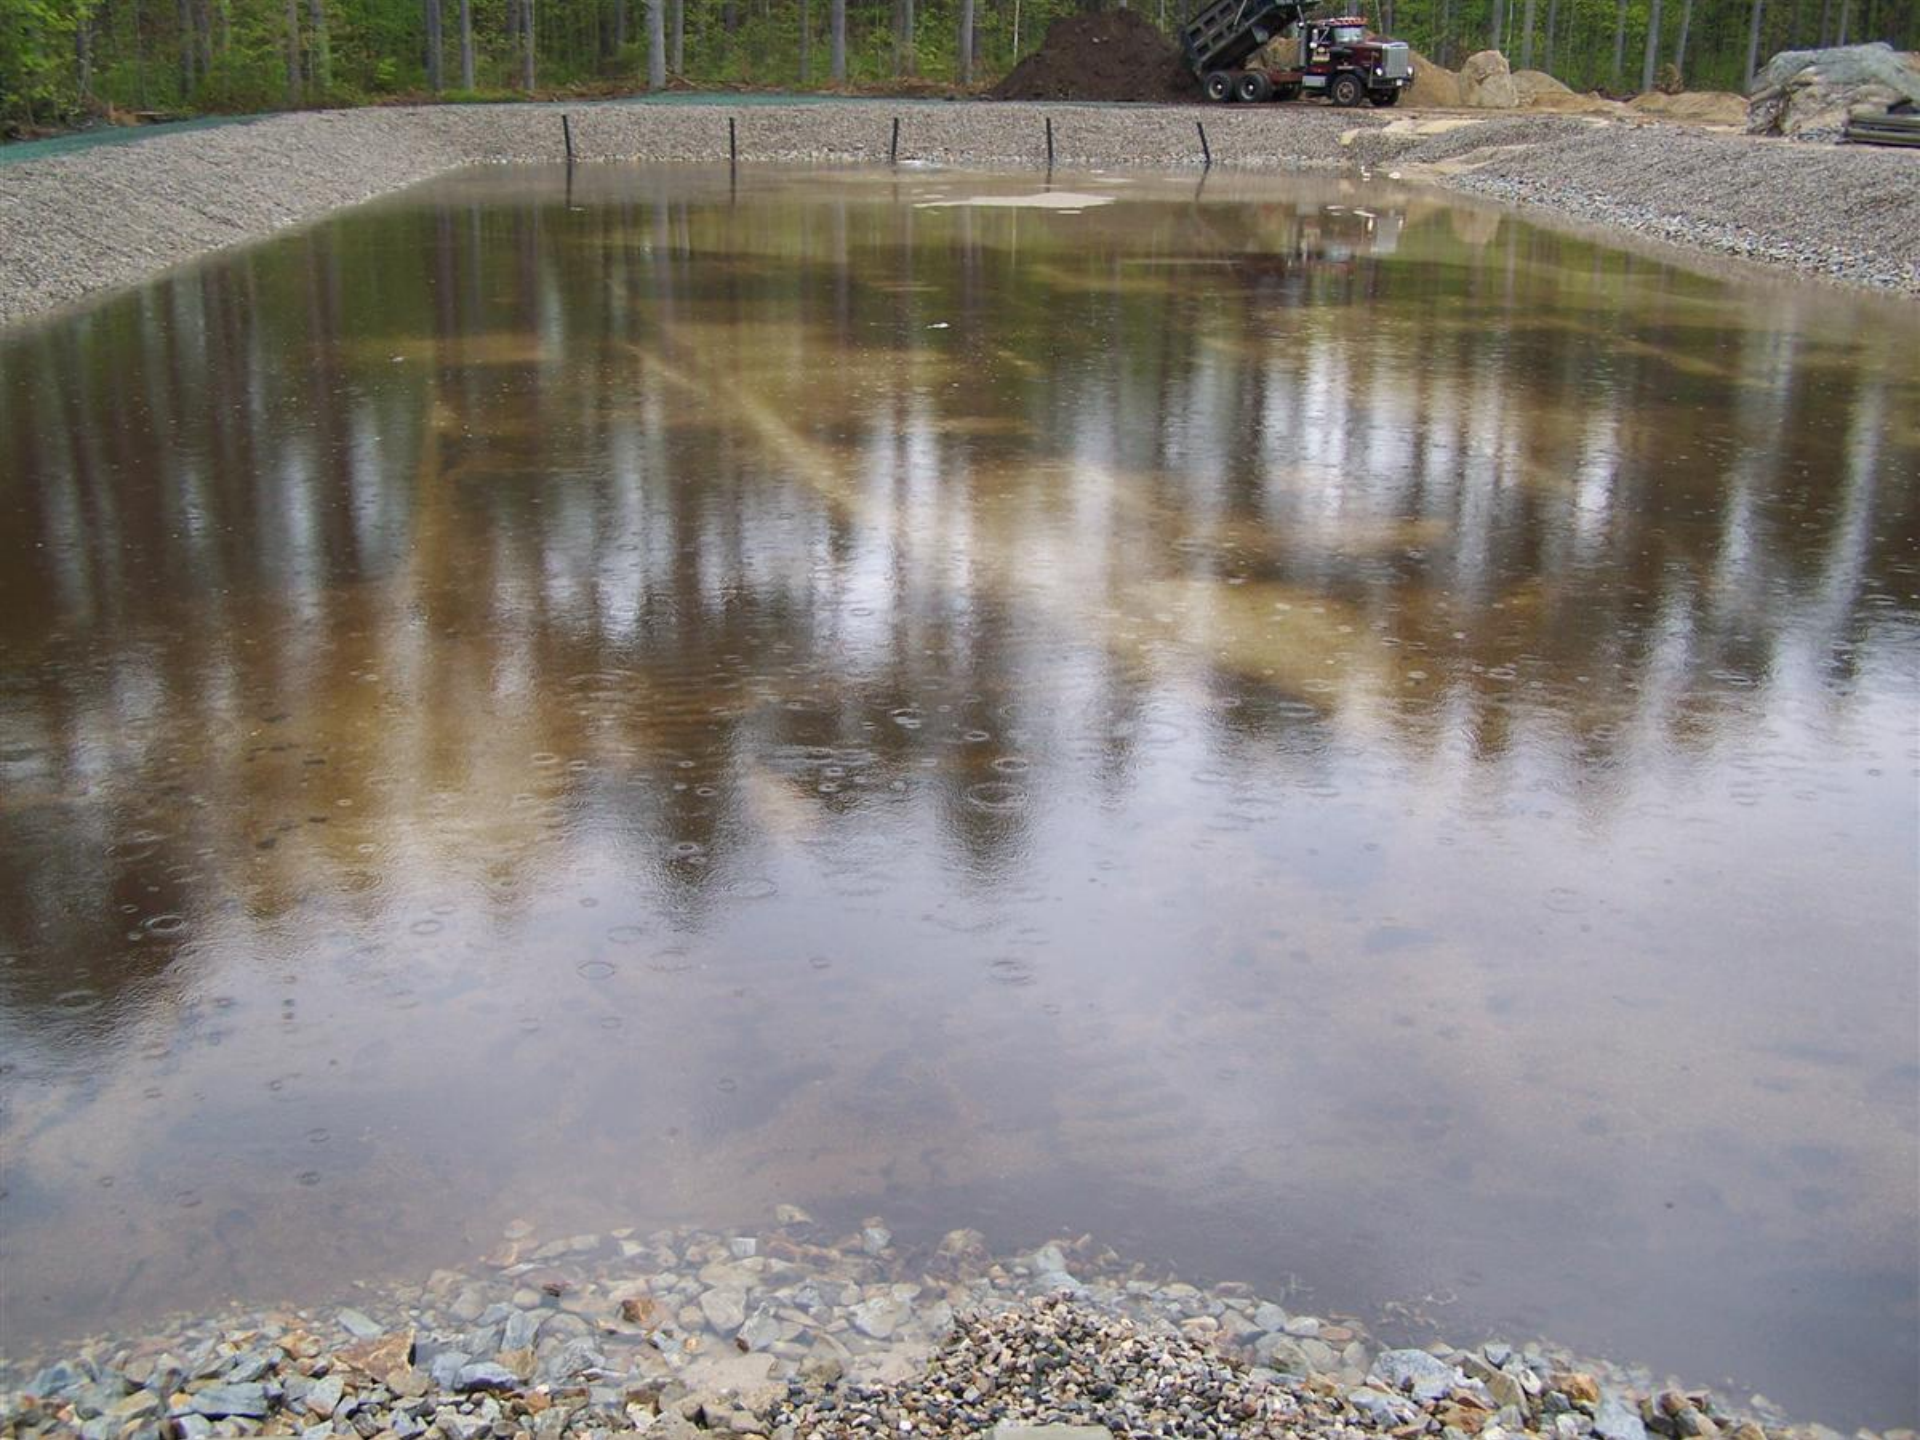
- HDPE liner & nonwoven geotextile fabric layer
- Washed sand “filter bed”
- Influent pipe and cement outfall pad

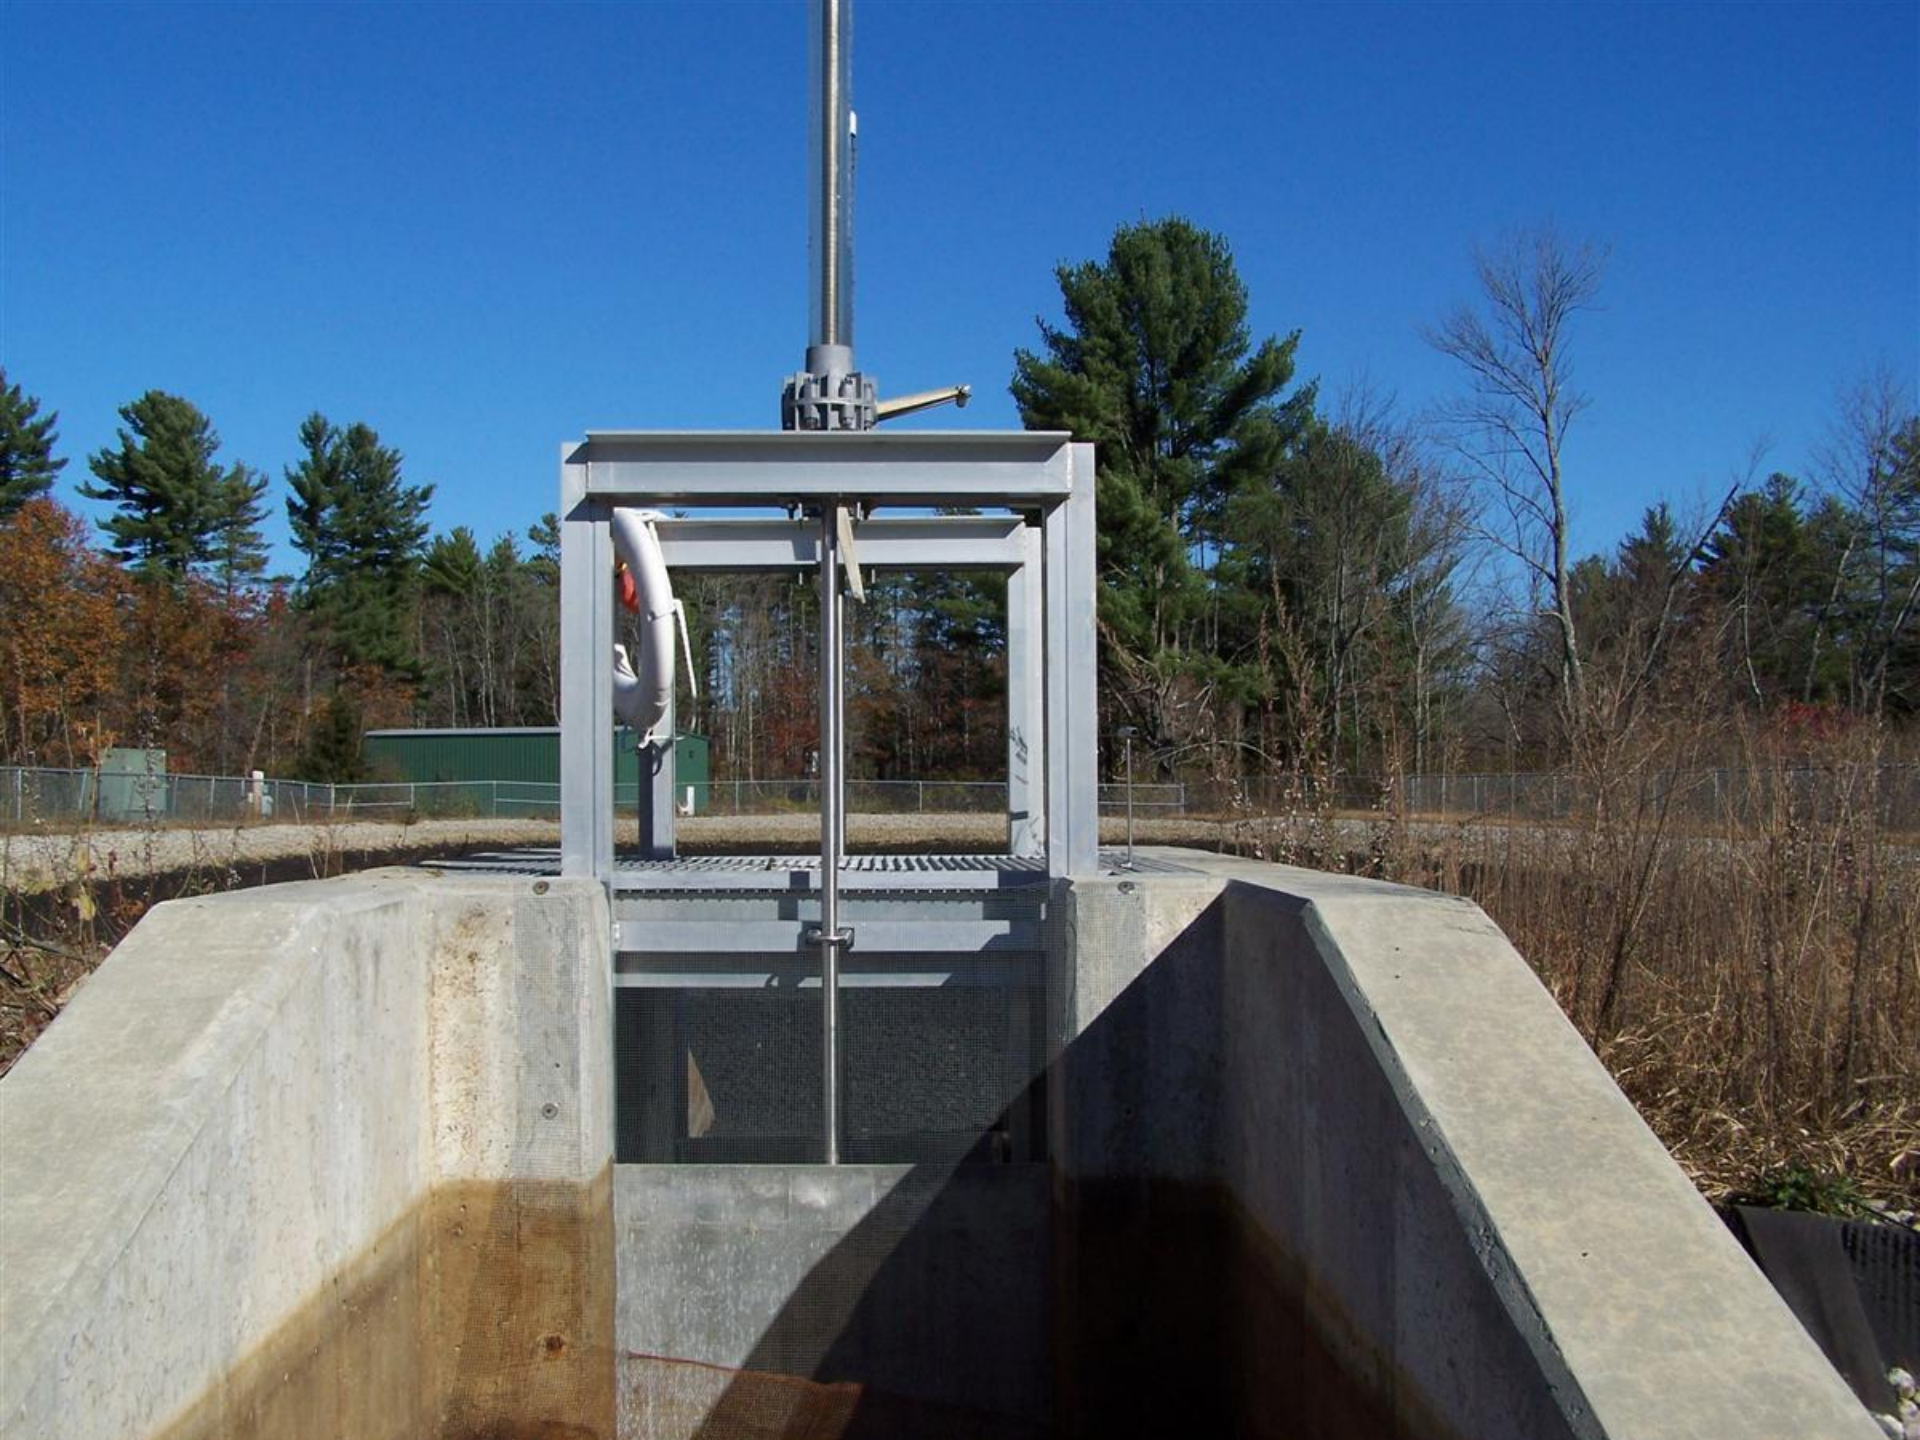
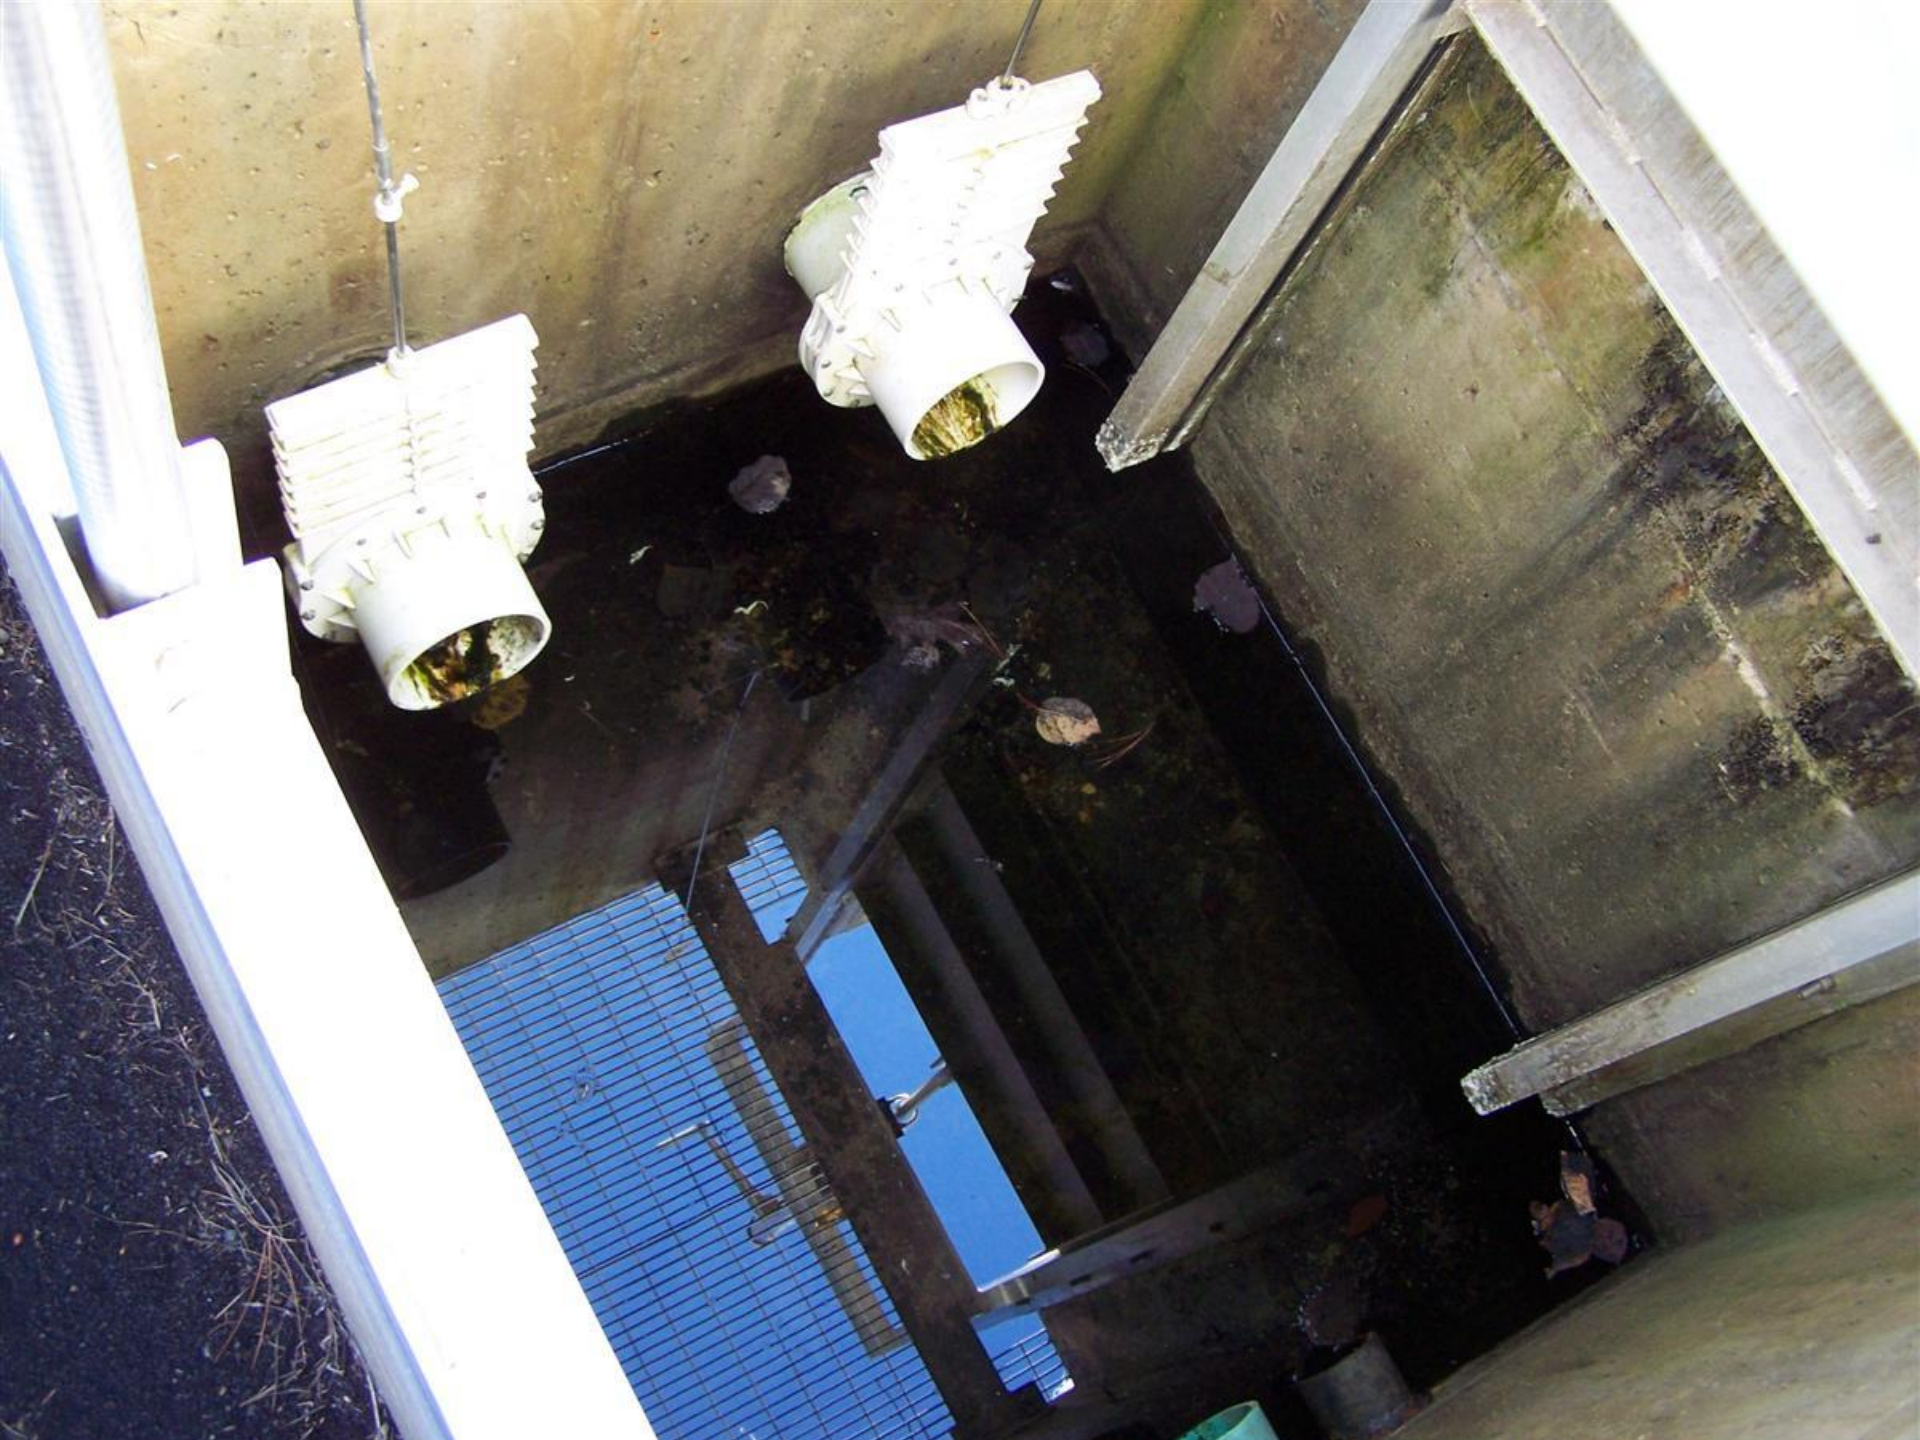
- Weir trough & valved collection system
- Excellent flow control
- Control filtrate and supernatant flow rates
- Quickly season beds with thick Schmutzdecke
- Make adjustments depending on rain and discharge volume from the plant.
