Residuals Management Somersworth Drinking Water Treatment Facility

**A HISTORICAL
OVERVIEW OF
SURFACE WATER
TREATMENT
RESIDUALS
HANDLING**

Ian Rohrbacher, Treatment Operator IV

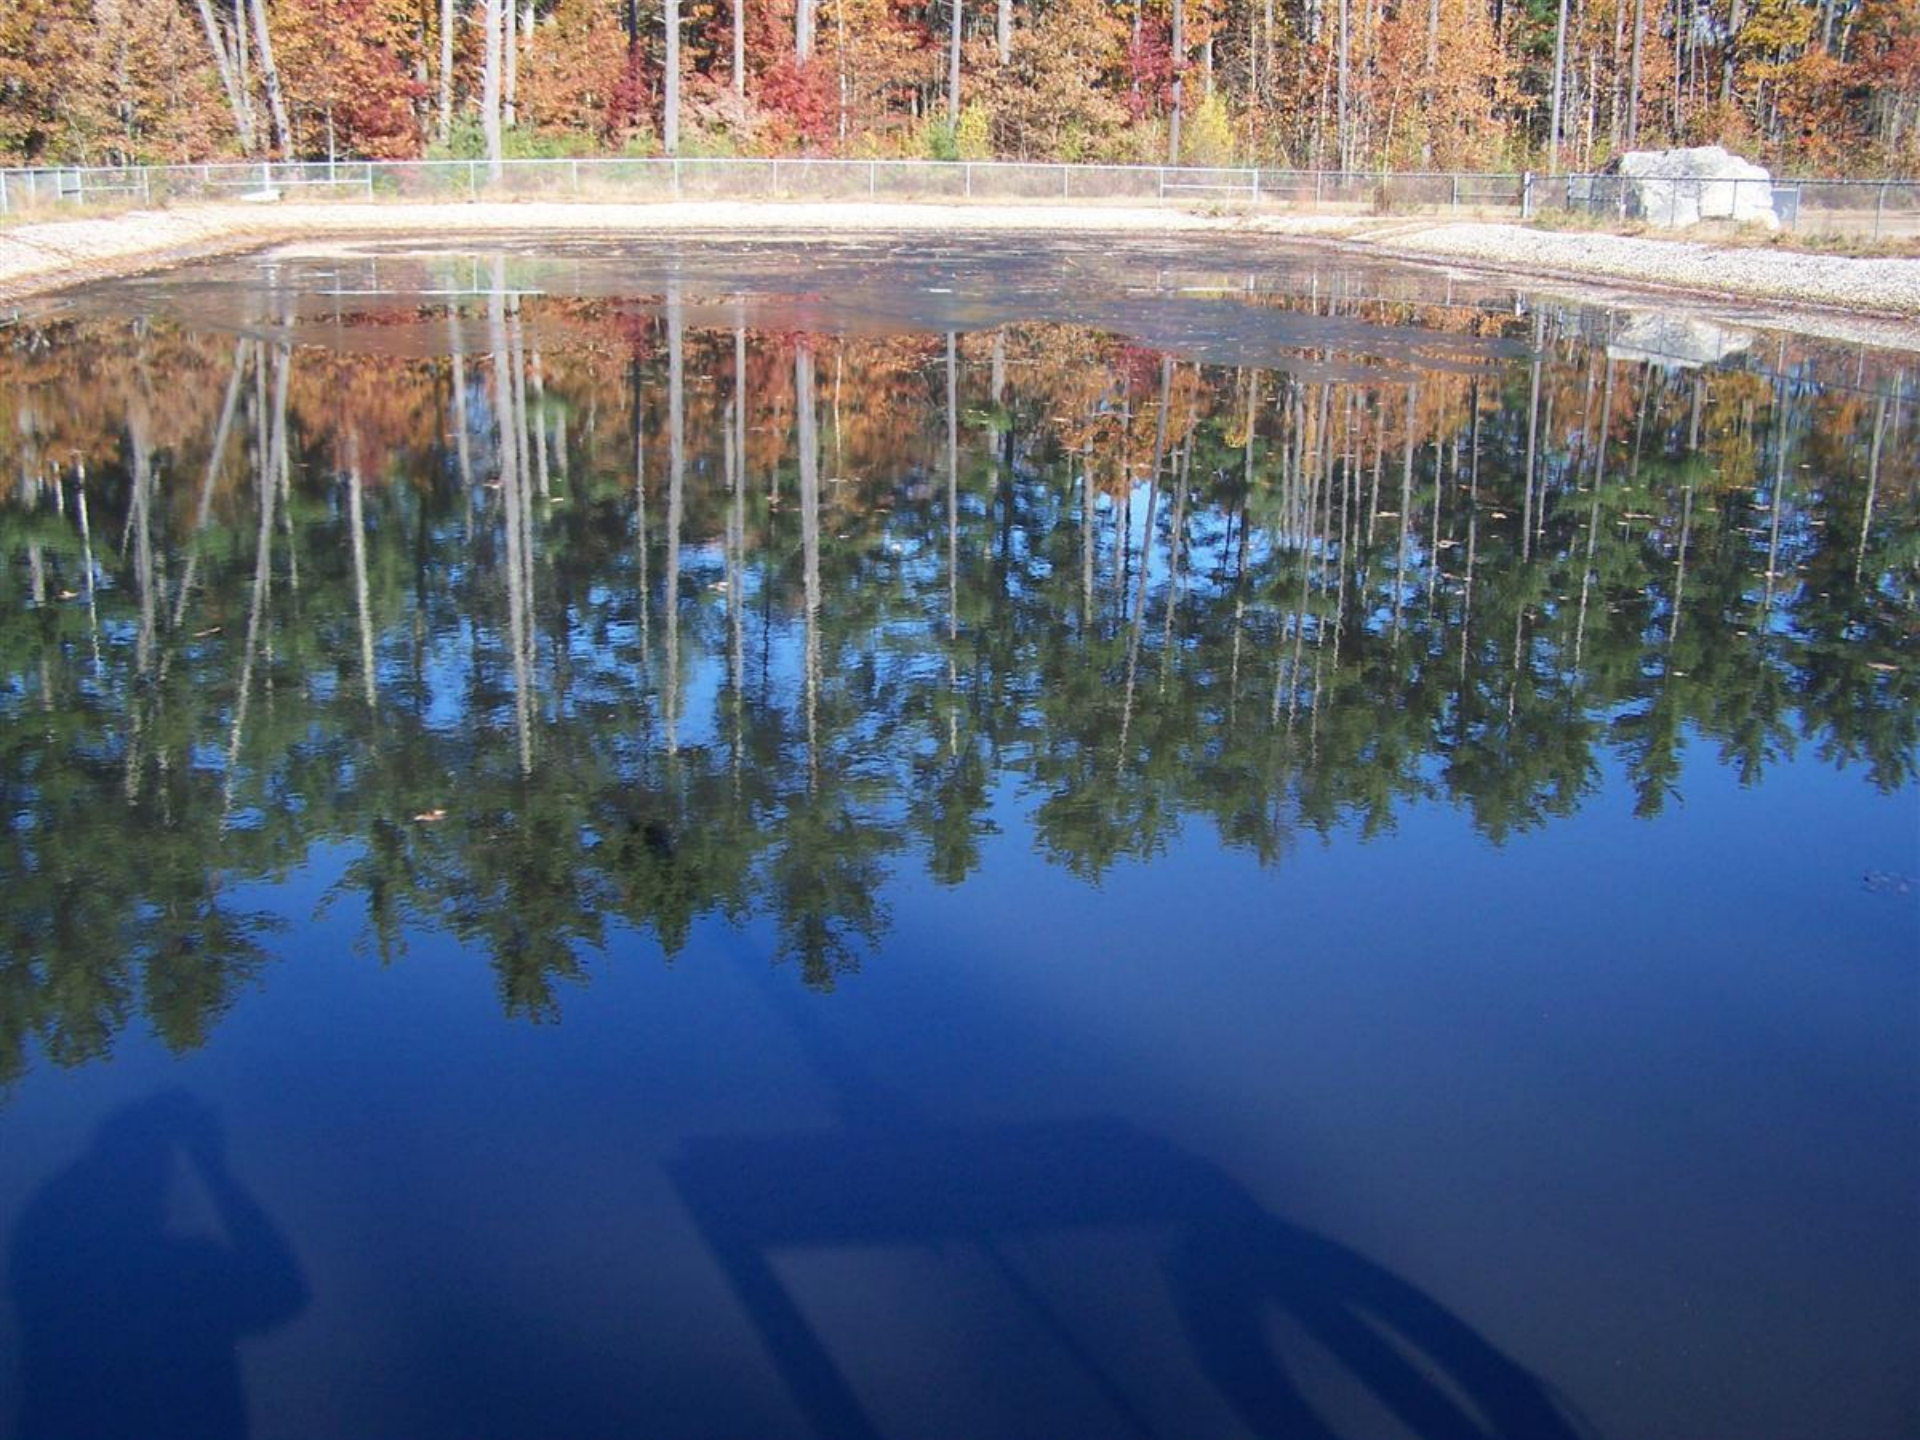
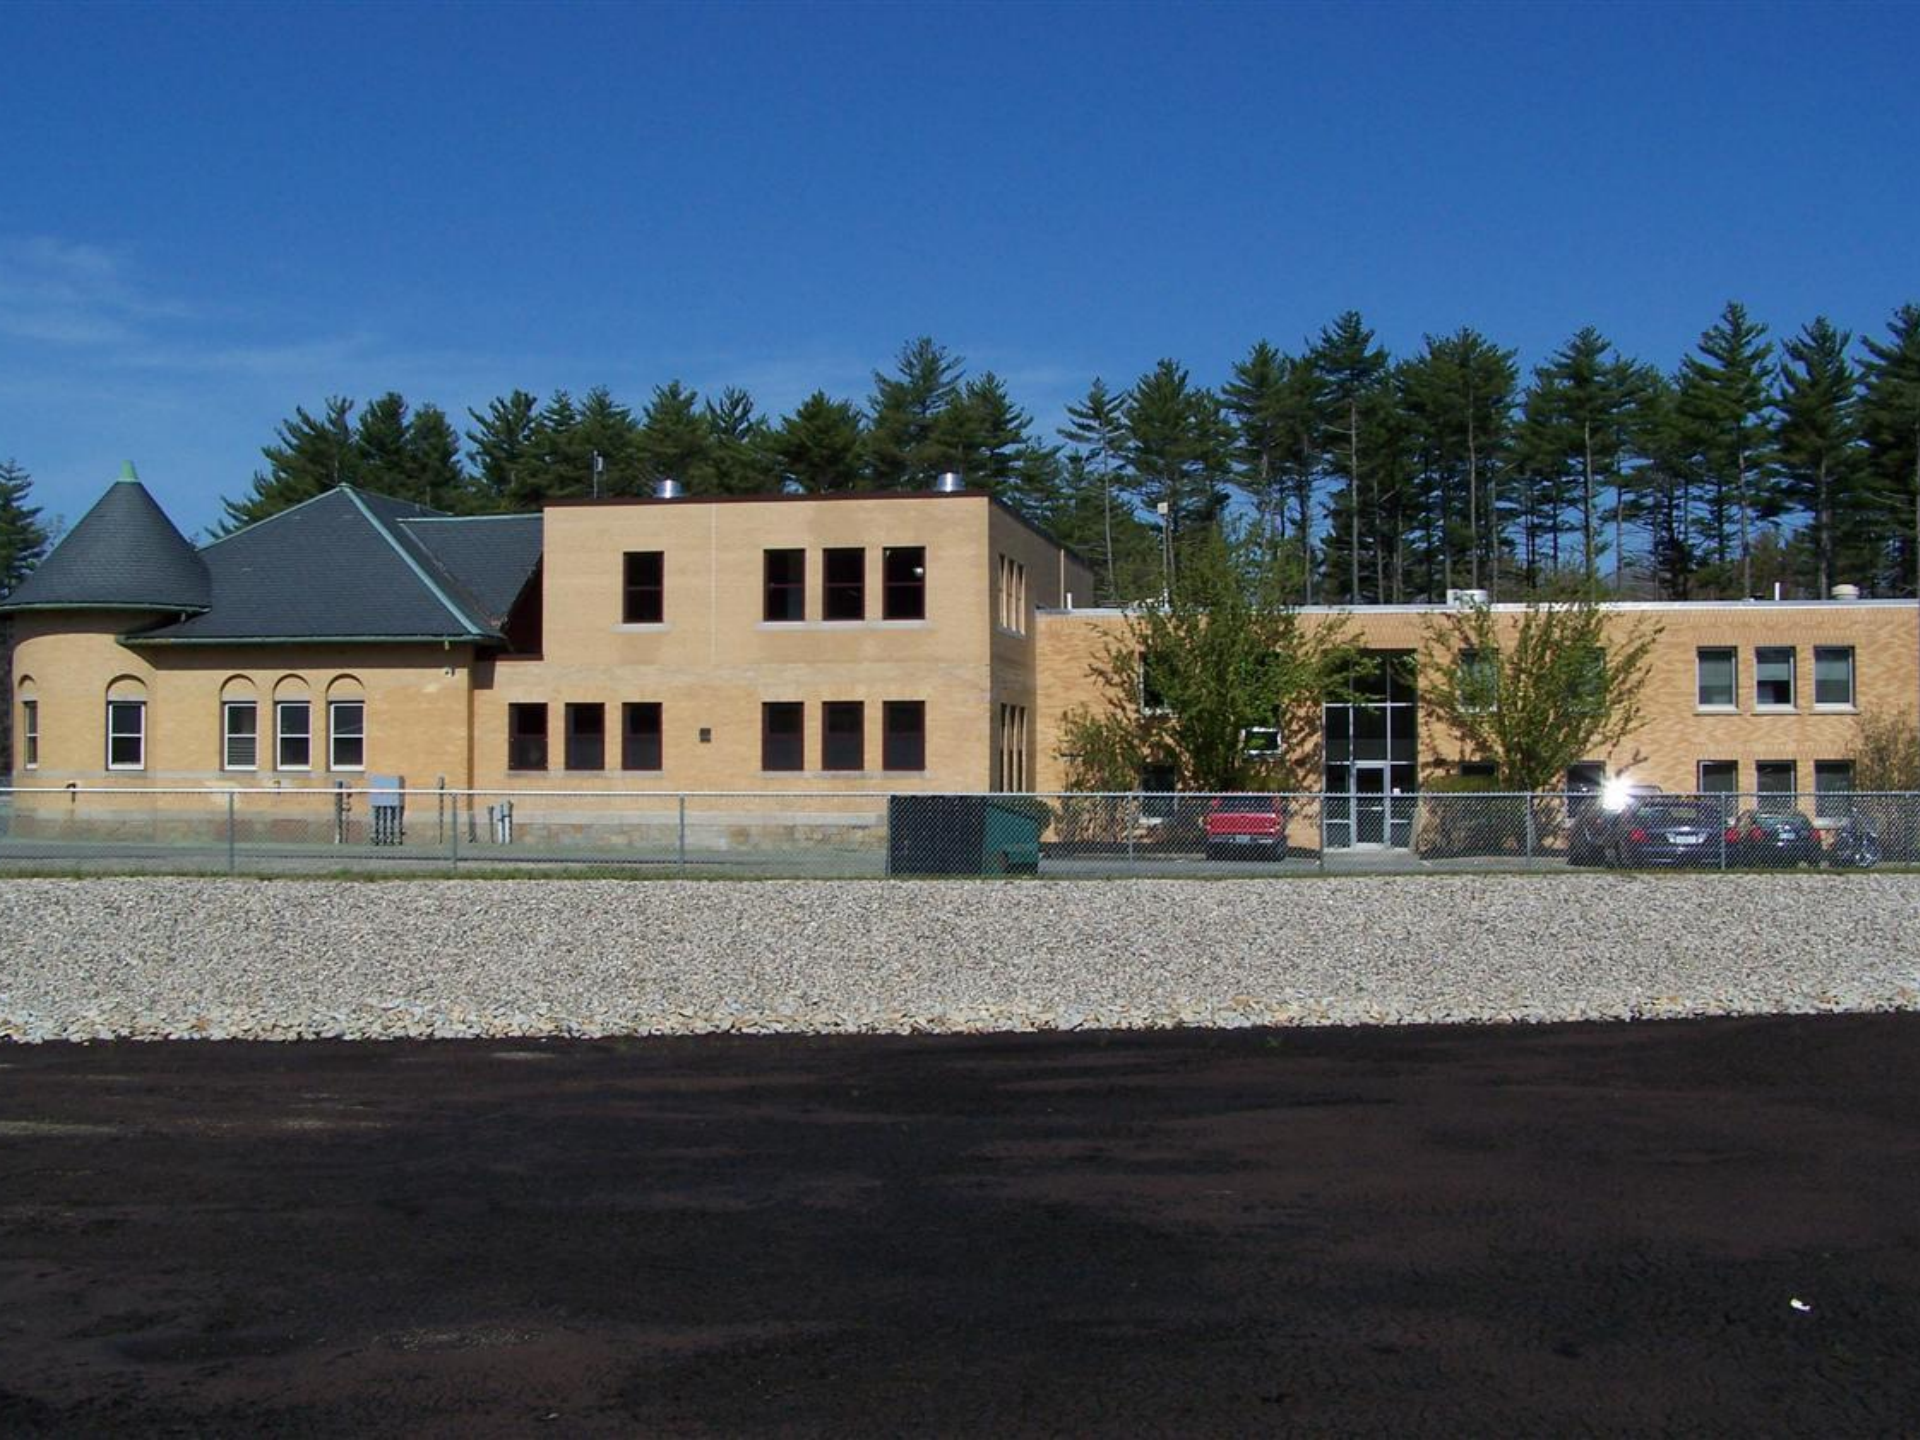
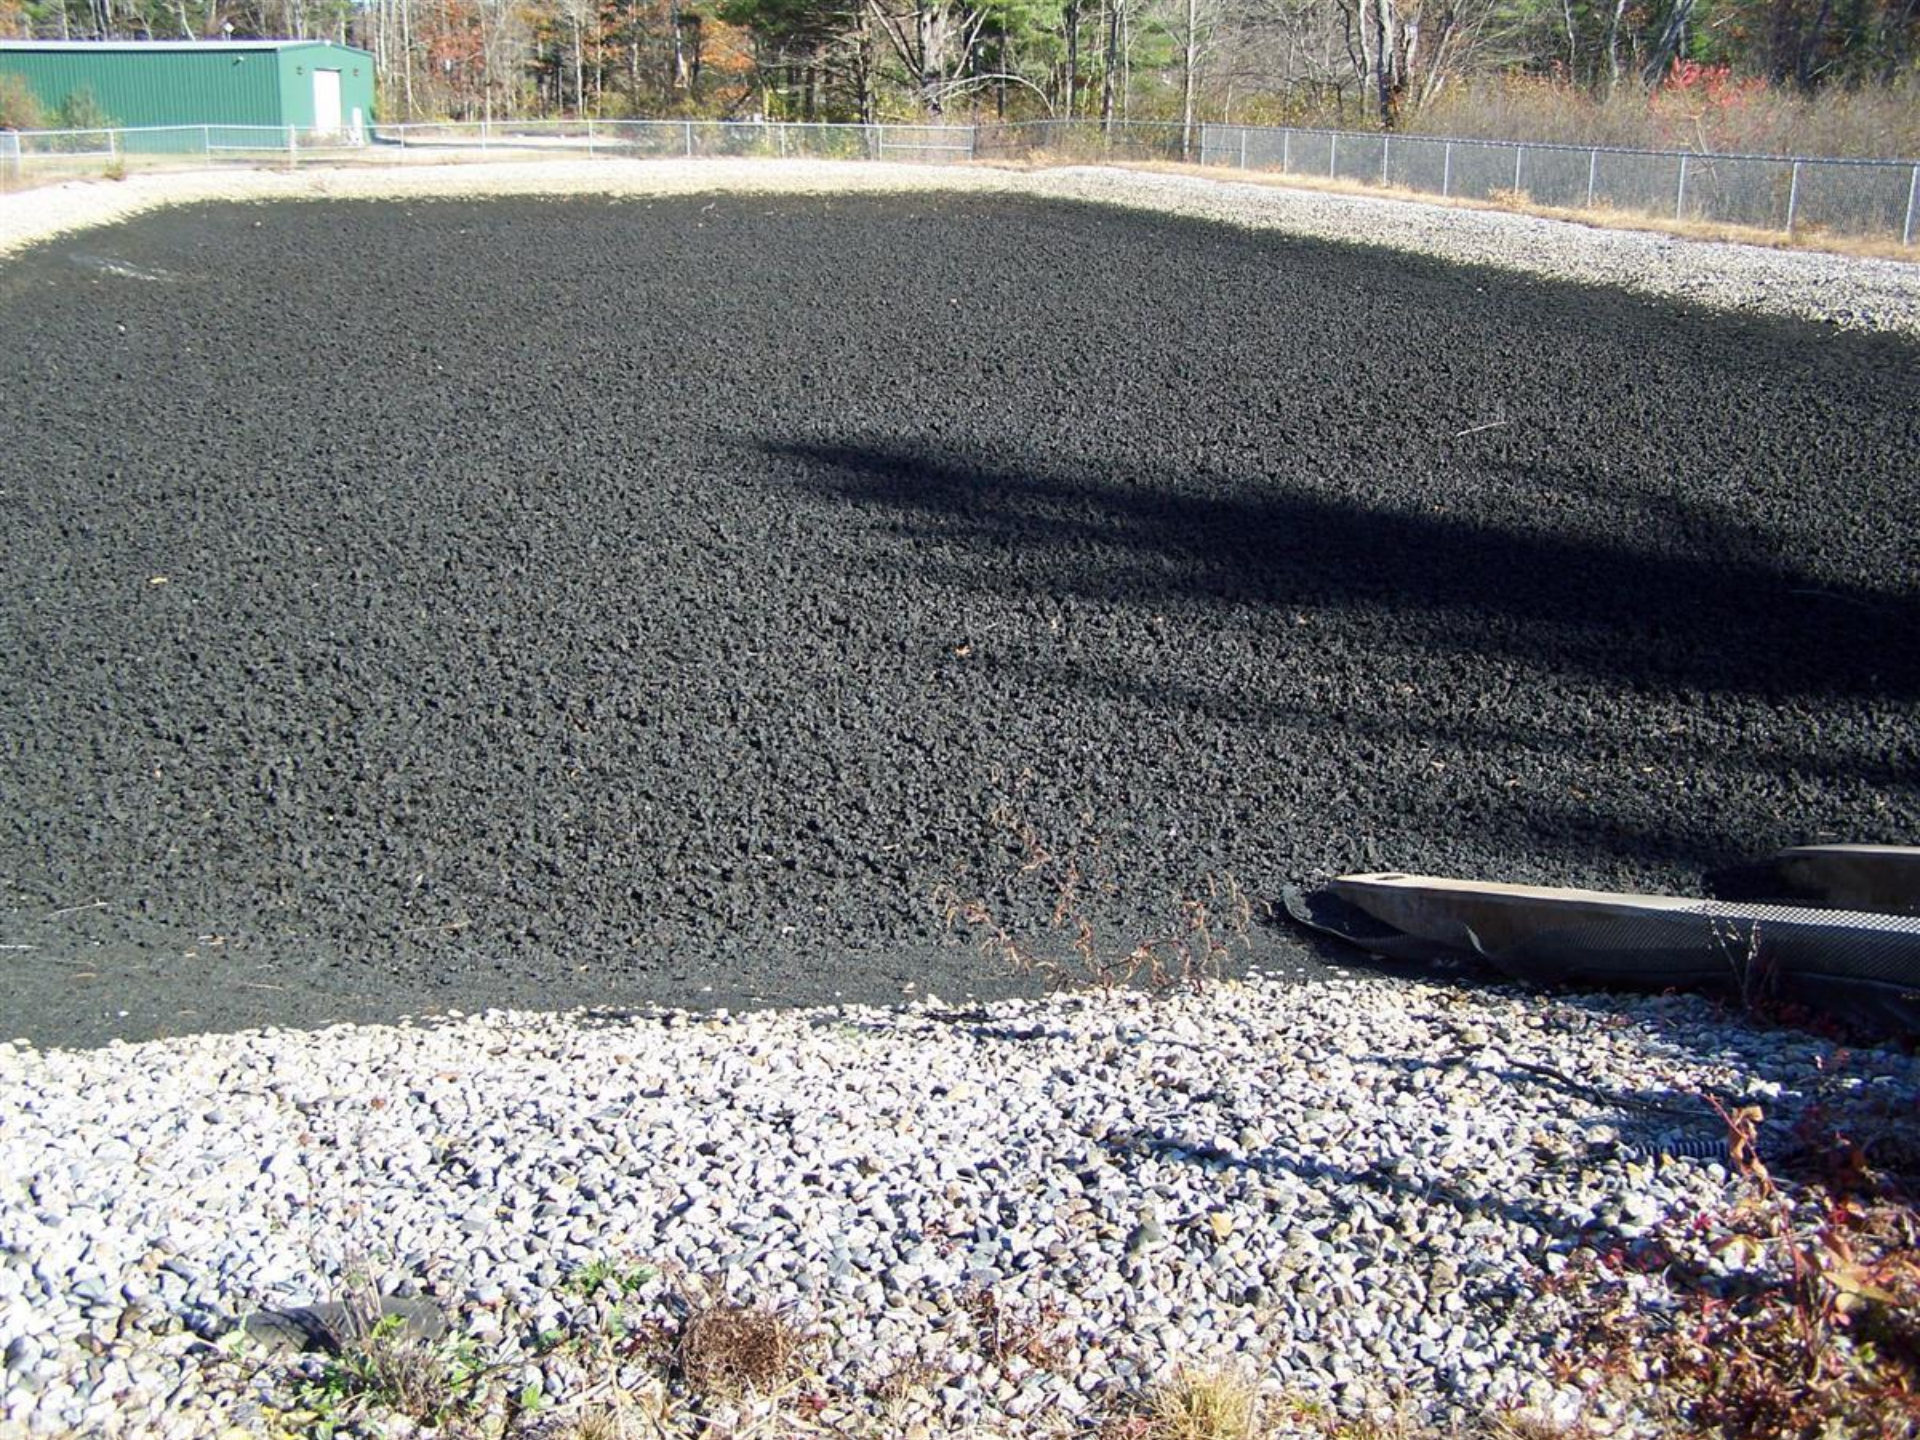
- We alternate & reuse the lagoons to maximize drying and layering
- Sand/membrane beds facilitate rapid dewatering
- Each lagoon filled to ~4ft of hydrated material
- Stop flow. Dries to ~18 inches of alligatored clumps with tops as dry as anthracite and a thick jelly at bottom.
- We could repeat this process 2-3 times
- Drying time measured in months
- Had three lagoons to fill. Why worry? What's the rush?

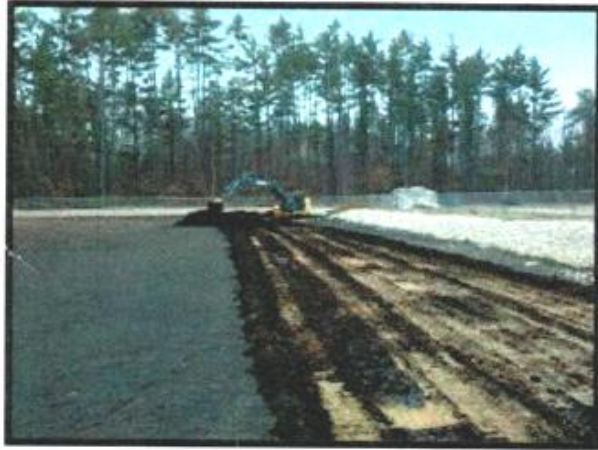
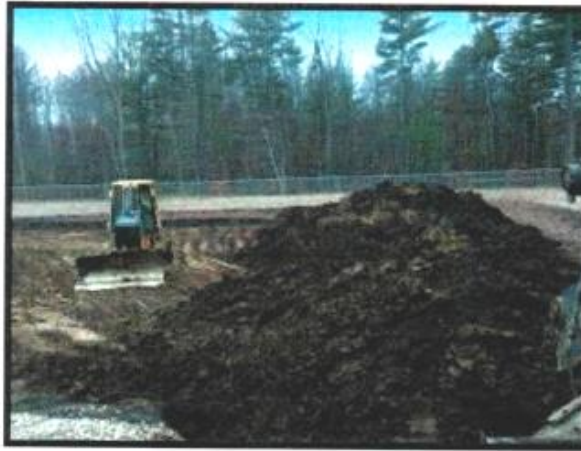
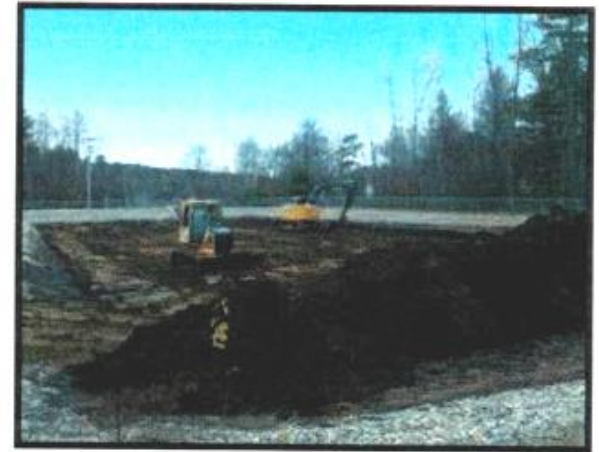
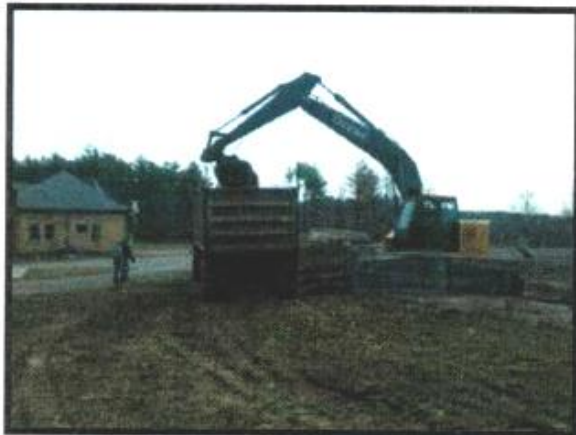
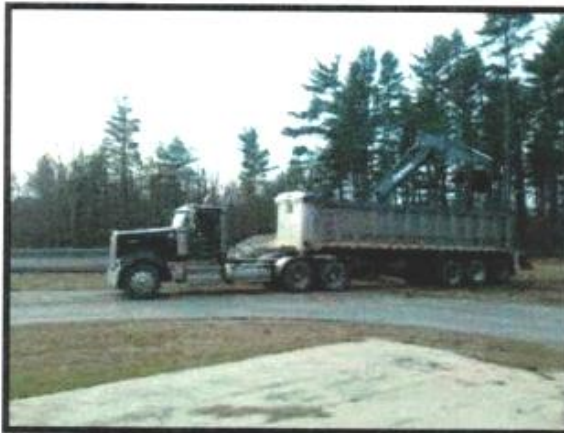
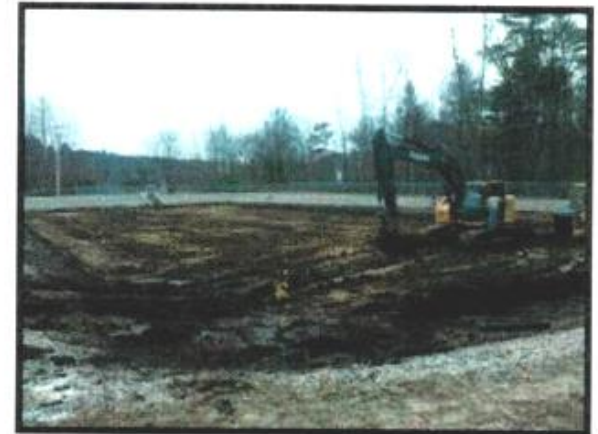
On November 16, 2010, RMI loaded the first of what would ultimately be 13 loads into trucks for removal. The hydrosolids were taken to an RMI end-user for use in manufactured topsoil blending. Twelve loads were removed on November 16. After the edges of the lagoon were cleared, the last load was removed on November 17, 2010. RMI removed its equipment on November 19, 2010 and will return to drag and seed the disturbed area outside the fence the week of November 29 or when site conditions have sufficiently dried up.

- RMI Mobilized
- On-site process completed in just a few days
- Included removal, grading, sand addition, site restoration
- Autonomous, timely
- No disruption to process or staff
- 2010 - Lagoon 1
 - 337 wet tons (381 yd³)
- 2011 – Lagoons 2&3
 - 586 wet tons (685 yd³)
- 2012 – Lagoon 1
- 2013 – Lagoon 2&3 upcoming
